Wheels & Brakes

# SERVICE BULLETIN

## POSSIBLE DEVELOPMENT OF CIRCUMFERENTIAL CRACKS IN CLEVELAND BRAKE DISCS USED ON CERTAIN MODELS OF THE PIPER PA-31 NAVAJO AIRCRAFT

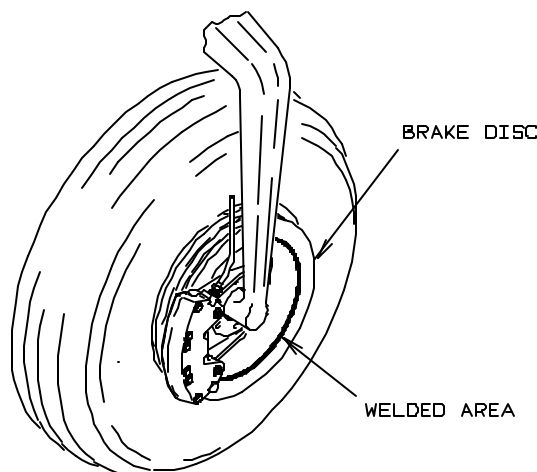
Sketch #1

Visually inspect the welded area (see Sketch #1) for evidence of circumferential cracks. This type of crack will split the paint and is readily visible to the naked eye. If cracks are found, replace with a new brake disc of the corresponding part number.
