# SERVICE BULLETIN

## LANDING GEAR - EMERGENCY EXTENSION - INSPECT/REPLACE AIR LINE

**EFFECTIVITY:** Piper, Model PA-31T2, Cheyenne II XL, S/N 31T-8166001 thru 31T-8166062, equipped with Parker Hannifin P/N 199-111, Wheel and Brake Conversion Kit.

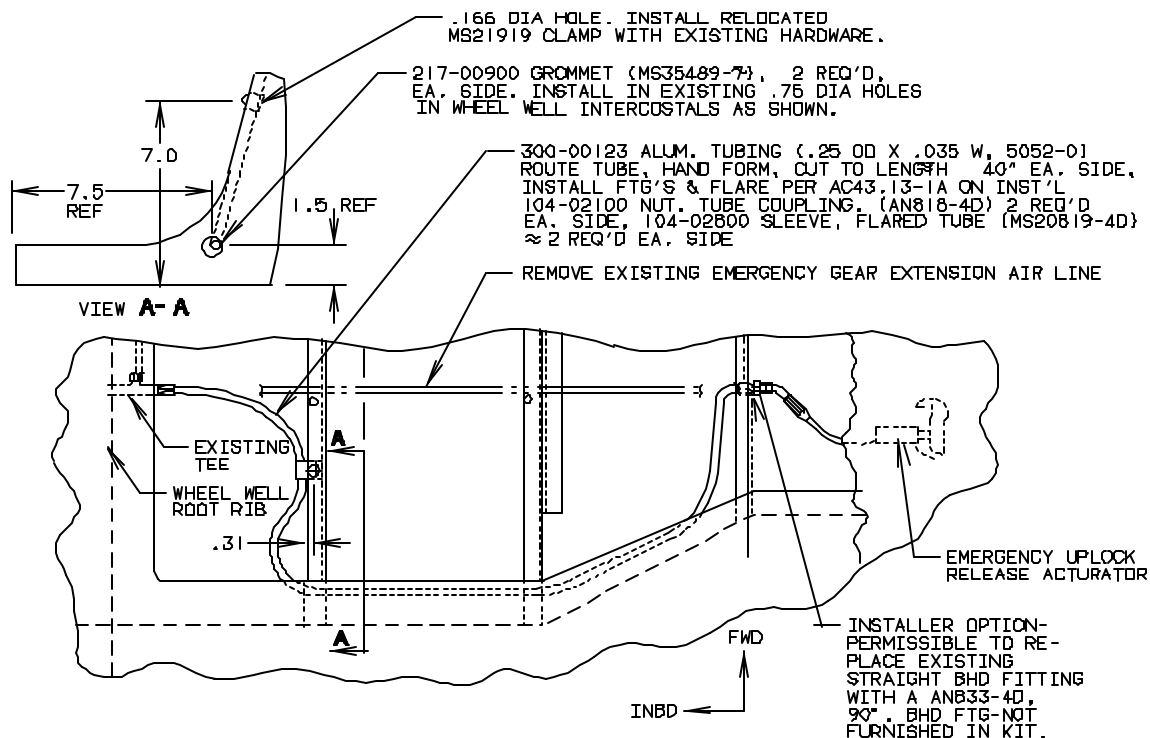
**REASON:** Improved Reliability - the combined effects of landing gear rigging, brake lining wear and routing of the emergency gear extension air line can allow the brake cylinder to chafe against the air line when gear is in the up and locked position. Continuous chafing may result in damage to the air line.

VIEW LOOKING UP-LT MAIN LDG GEAR WHEEL WELL-SHOWN, OPP FOR RT.

1. Review log books and inspect main wheel area to determine if a modification to re-route the emergency extension air line (Ref. Fig. 1) has already been accomplished. If not, proceed as follows.
2. Jack aircraft per the aircraft maintenance manual.
3. Disable emergency extension system per the aircraft maintenance manual.
4. Remove existing emergency extension air line (aluminum tubing) between the tee, outboard of the wheel well root rib and the emergency uplock release actuator.
5. Install new air line as shown on Figure 1.
6. Re-enable the emergency extension system per the aircraft maintenance manual.
7. Perform functional tests of both normal and emergency landing gear system, per aircraft maintenance manual.
8. Remove aircraft from jacks and make proper log book entry of accomplishment.

INSTALL EMERGENCY GEAR EXTENSION AIR LINE TO CLEAR BOTH LEFT AND RIGHT BRAKE CYLINDERS  
(EFF. FOR AIRCRAFT S/N'S 31T-1166001 THRU 31T-8166062)
