How to Avoid the Most Common Bus/Coach Kneeling Failures

**By Paxton Augustine, Product Marketing Manager
Parker Hannifin Corporation
Pneumatic Division – Richland, Michigan**

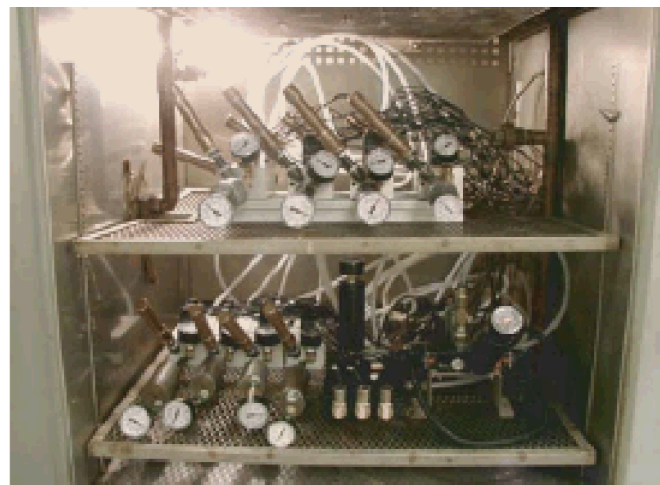
Figure 2:
Temperature test set-up

Testing Method – Using 10 kneeling modules, 24 temperature tests were conducted. Six 3-station 24VDC and four 4-station 24VDC units were used for this test. With 100-psi air to each module's supply port, 6.5 cubic inch volume chambers connected to the right airbag & leveling valve ports, and 3 cubic inch chambers to the left airbag & leveling valve ports, the tests measured for leaks under the following conditions:

- Room temperature
- Low temperature and high temperature profiles; with and without a dryer
- Six-to-eight day duration cycling tests at different temperature profiles
- Sticking tests at different temperature profiles

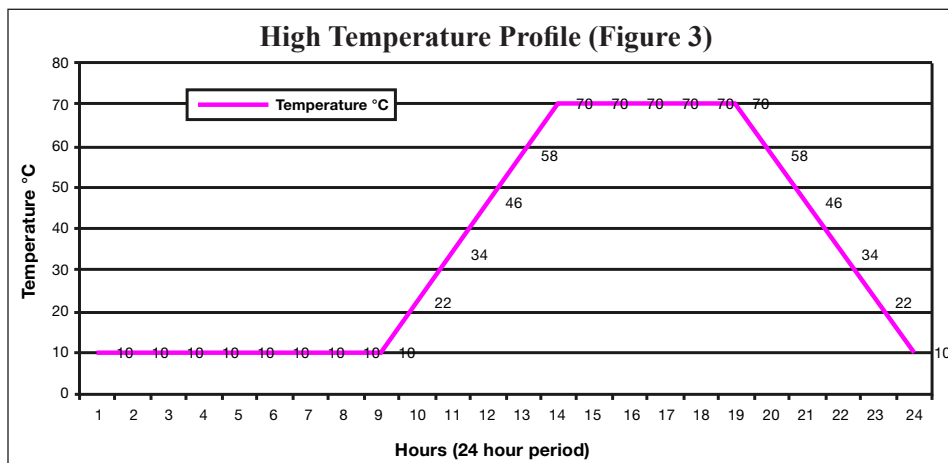
This extreme hot temperature cycle simulates summer operation.

As noted, the hot temperature profile shown in Figure 3 was used to simulate summer operation. The cold temperature profile shown in Figure 4 was used simulate winter operation over a 24 hour period. The temperatures ranged from -40°F (-40°C) to 158°F (70°C). All supply ports for each module were connected to a distribution manifold to allow total leakage to be checked individually by a flow meter. A Programmable Logic Controller (PLC) was used to time the exhaust from the modules to minimize air pressure spikes inside the chamber. The PLCs were programmed to both automatically cycle the modules during normal testing or provide for manual control so that individual solenoids could be activated for leakage checks.

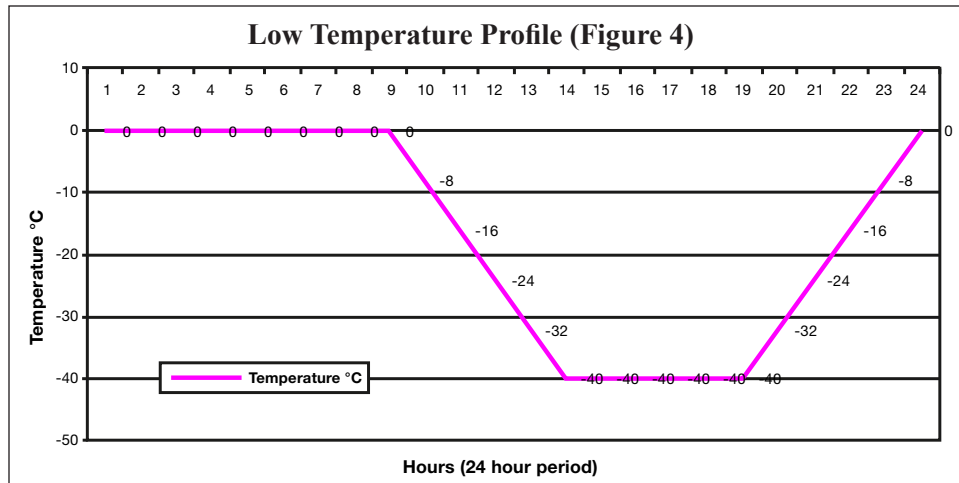
This extreme cold temperature cycle simulates winter operation.

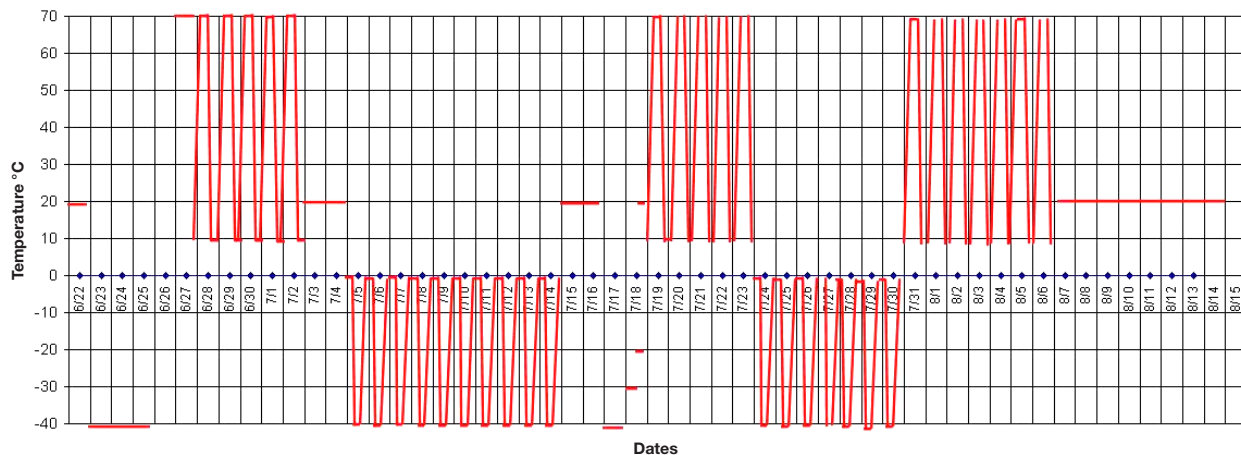
Endurance Test Time Line (Figure 5)

The cycle rate used for testing was 34 cycles per minute and the test duration equated to 20 years of intensive operation: 2,102,400 cycles calculated; assuming one (1) complete kneeling cycle every five (5) minutes for a non-stop duration of 20 years. Shown below in Figure 5 is the profile for the cycle testing as the modules were continuously exposed to either the summer or winter profile. Both seasonal profiles were alternated weekly throughout the entirety of the life cycle testing.

- An operational cycle for a 4-station unit:
 - Supply, left and right airbag solenoids all on
 - Supply, left and right airbag solenoids all off
 - Exhaust, left and right airbag solenoids all on
 - Exhaust, left and right airbag solenoids all off
- An operational cycle for a 3-station unit:
 - Supply, left airbag solenoids both on
 - Supply, left solenoids both off
 - Exhaust, left airbag solenoids both on
 - Exhaust, left solenoids both off

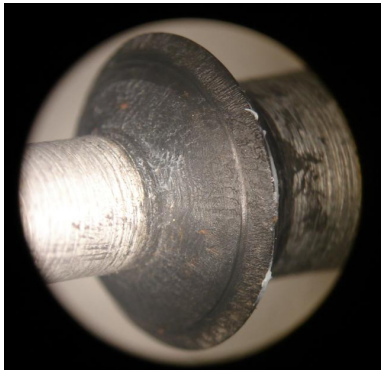
Figure 6:
*Over-molded poppet removed
from kneeling module after
2 million cycles*

Test Results – At room temperature, all of the modules tested were leak free when solenoids were de-energized - normal ride mode for the bus. When filling airbags, all modules were also leak free. During the airbag exhausting phase, one 4-station module had excessive leakage due to an o-ring failure at the 800,000 cycle point (approx. 8 years). Upon completion of the cold and hot sticking tests, with the restoration of warmer temperature, all modules were leak free. All modules continued functioning during low temperature testing, but developed excessive leaks. As the test progressed, most of the low temperature leakage stopped when temperatures rose. Wear on the over-molded poppet (Figure 6), along with the poppet o-rings was minimal. Upon further examination after the completion of the test, it was discovered that the failed o-ring was due to a molding defect in the product and not as a result of the cycle testing.

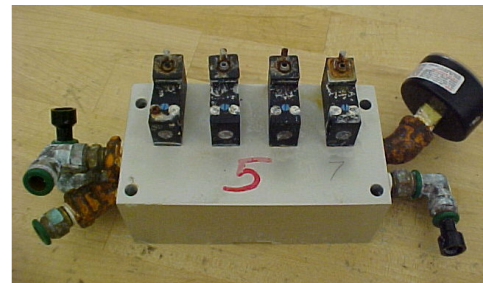
Figure 7:
Kneeling module after Salt Spray Testing

Test Results – All four kneeling modules functioned properly following the first 200-hour Salt Spray Test. Each unit showed some oxidation around the solenoid valves and steel pipe fittings; but there was no oxidation on aluminum parts or internal components (See Figure 7). Results of the second test showed that both solenoid and solenoid pilot operators were still operational after 500 hours of salt spray testing. The solenoid mounting screws were heavily oxidized at the completion of the soak test. See Figure 8 below.

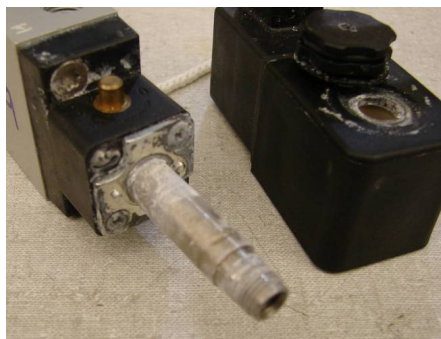
Figure 8:
Salt Spray Testing performed on pilot operator and coil

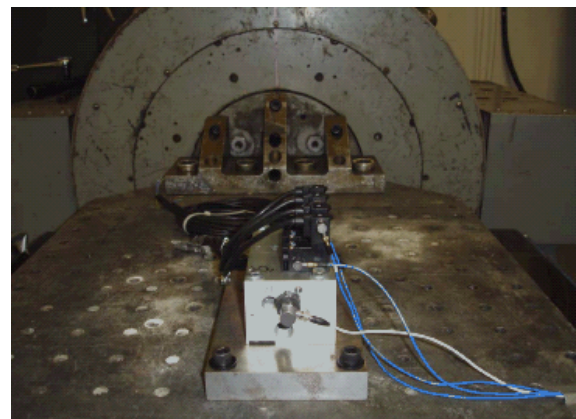
Figure 9:
 Lateral axis set-up

Testing Method – Four 4-station modules were mounted on a vertical axis. Four bolts were used to attach the module to a fixture; 120 in-lbs of torque was applied. A five (5) minute resonance sweep was performed to determine peak frequency (10-2500Hz at 2Gs) and then a durability test for 100,000 cycles was performed at that frequency. These procedures were then repeated for both horizontal and lateral axes. See Table 1 below.

of any malfunction (Figures 9 and 10). The supply valve on the module was opened, the left valve checked, followed by the right valve. The exhaust valve was then opened to release trapped air.

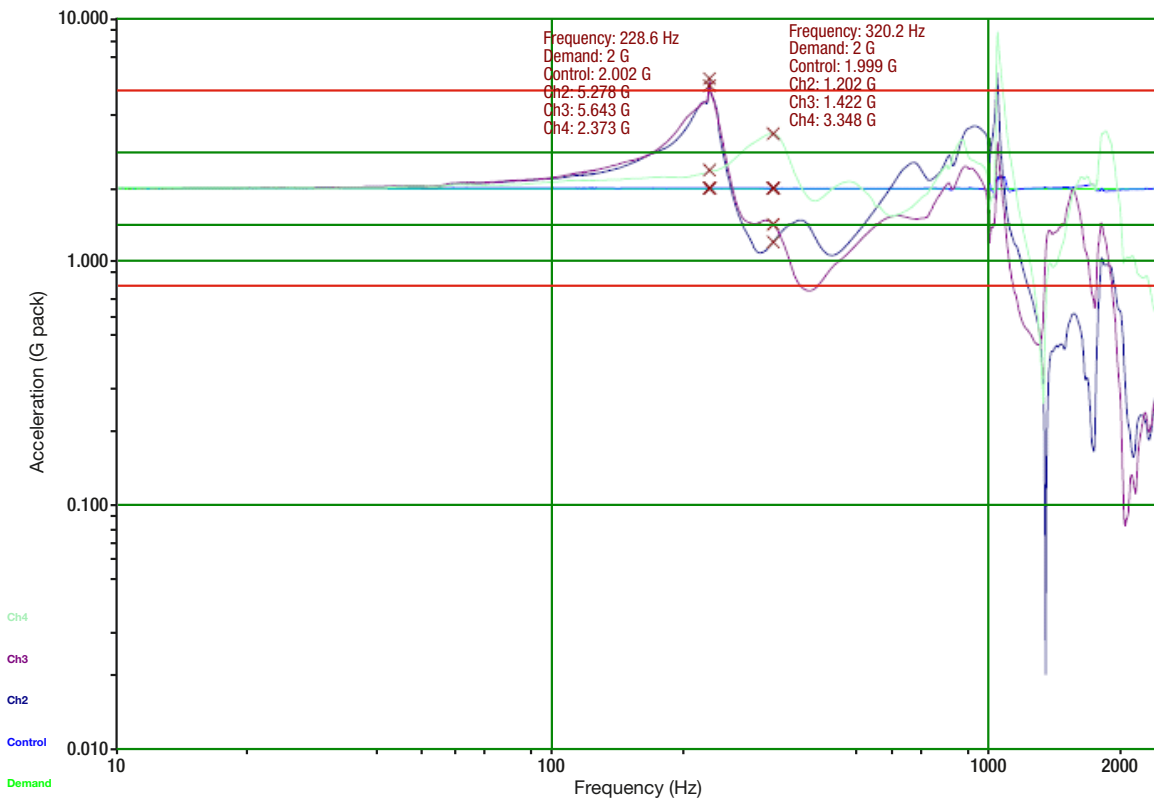
Acceleration Profile (Figure 10)

| Demand: 2G | Level Time: 0:05:00 | Frequency: 2500 Hz | Vertical Axis Resonance Sweep |
| Control: 0.000106 G | Total Time: 0:05:08 | End of Sweep Test | Block 4 (Response on Parts 1,2,3) |

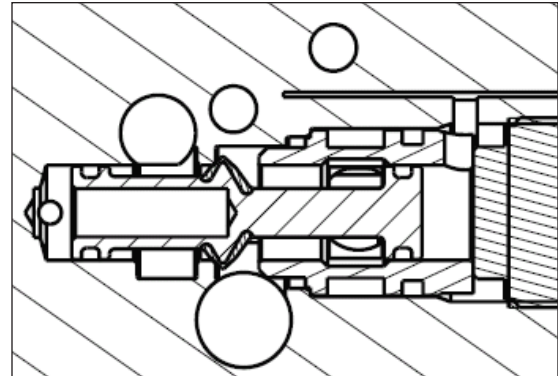
Figure 11:
Cross-sectional view of an over-molded poppet assembly

Over-Molded Poppet Valve Design – Although listed second, this key design point is certainly just as important as the first, if not more. The life and performance of the kneeling module rests almost entirely on the performance of this component. The quality of design and manufacturing of the poppet valve can both influence the life cycle failure mode, as well as, the leakage. The poppet assembly was also the most affected by all three failure mode causes identified (temperature, contamination, and vibration) and, as a result, was the most affected component during all the various tests conducted.

Observations - This low-temperature compound, precision ground poppet design, versus a spool design, was much better suited for harsh environments. A special over-molded rubber was used on the valve, which is suitable for both low and high temperature applications, ranging from -40°F to +158°F. Since the valve was designed with fewer components, there were less possible failure modes as a result. Performance wise - the valve's higher flow rate allows the bus to raise and lower at a faster pace compared to other modules observed.
