# THERM-A-GAP™ GEL 75 Reliability Report

## TR1103 March 2022 Rev. B

Chomerics Division of Parker Hannifin  
77 Dragon Court, Woburn, MA 01888  
(781) 939-4623

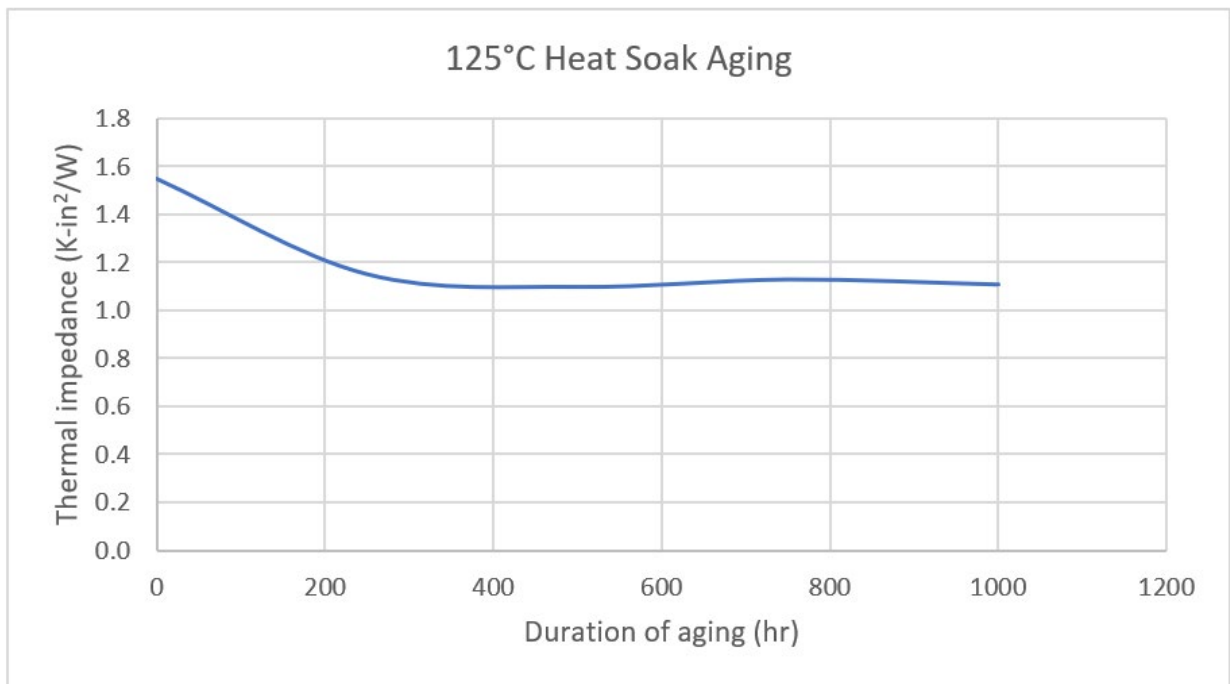
Figure 1: Dry heat aged thermal impedance versus time

The thermal performance of THERM-A-GAP™ GEL 75 was examined after being subjected to multiple environmental stress tests. The thermal impedance of the aged samples did not experience a significant increase after any of the treatments studied. After 1000-hour dwell at 125°C, 1000 hours at 85°C/85% relative humidity, and 1000 temperature cycles from -40°C to 125°C, there was no statistically significant change in impedance according to one-way ANOVA with the Tukey method for multiple comparisons. The mean value for thermal impedance decreased slightly for each aging treatment, indicating an improvement in thermal performance.

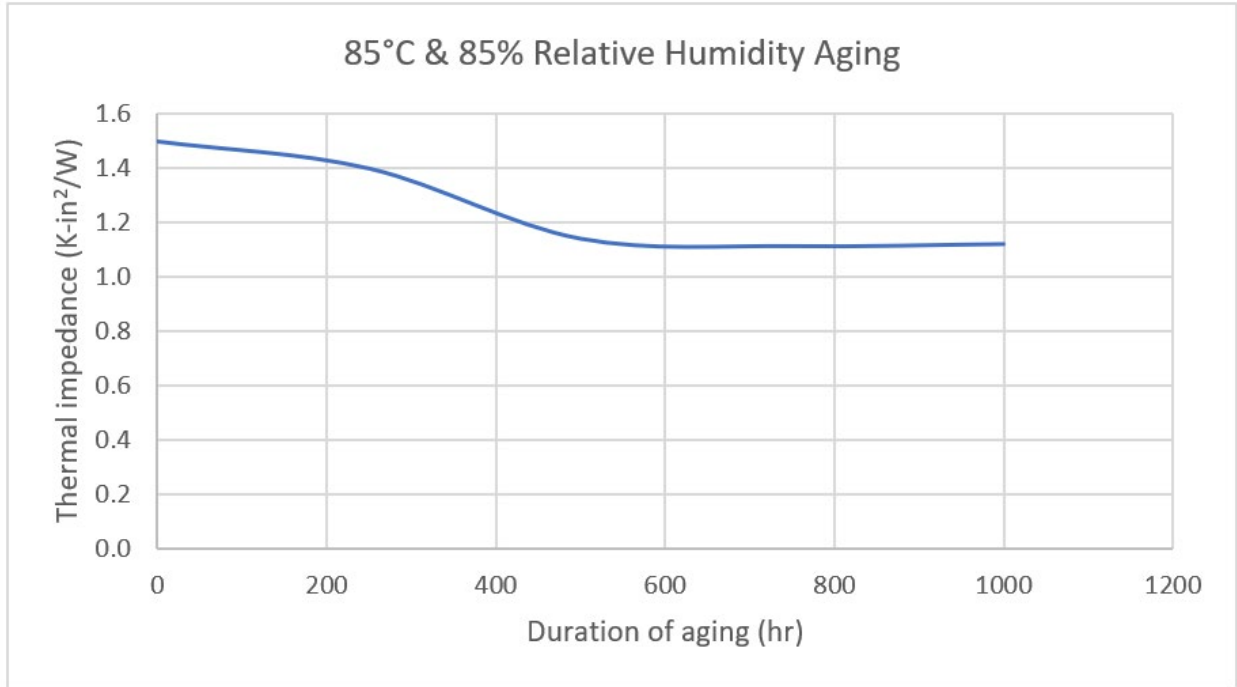
Figure 2: Heat & humidity aged thermal impedance versus time

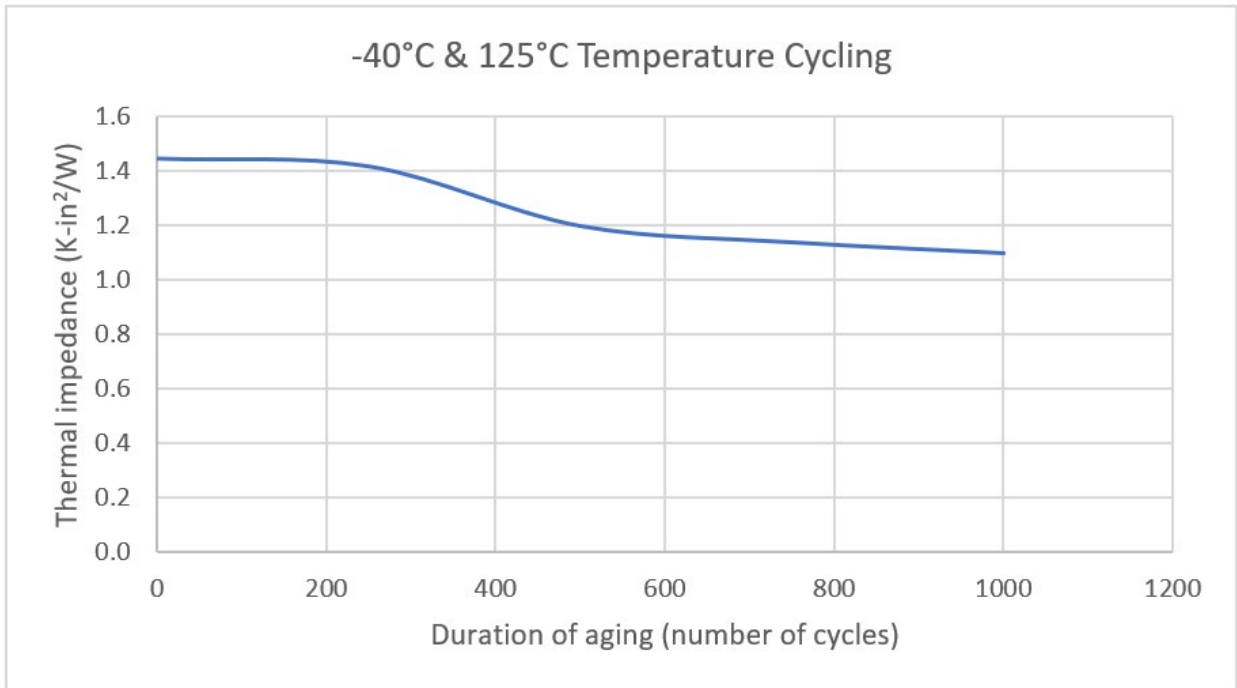
Figure 3: Temperature cycling thermal impedance versus elapsed cycles

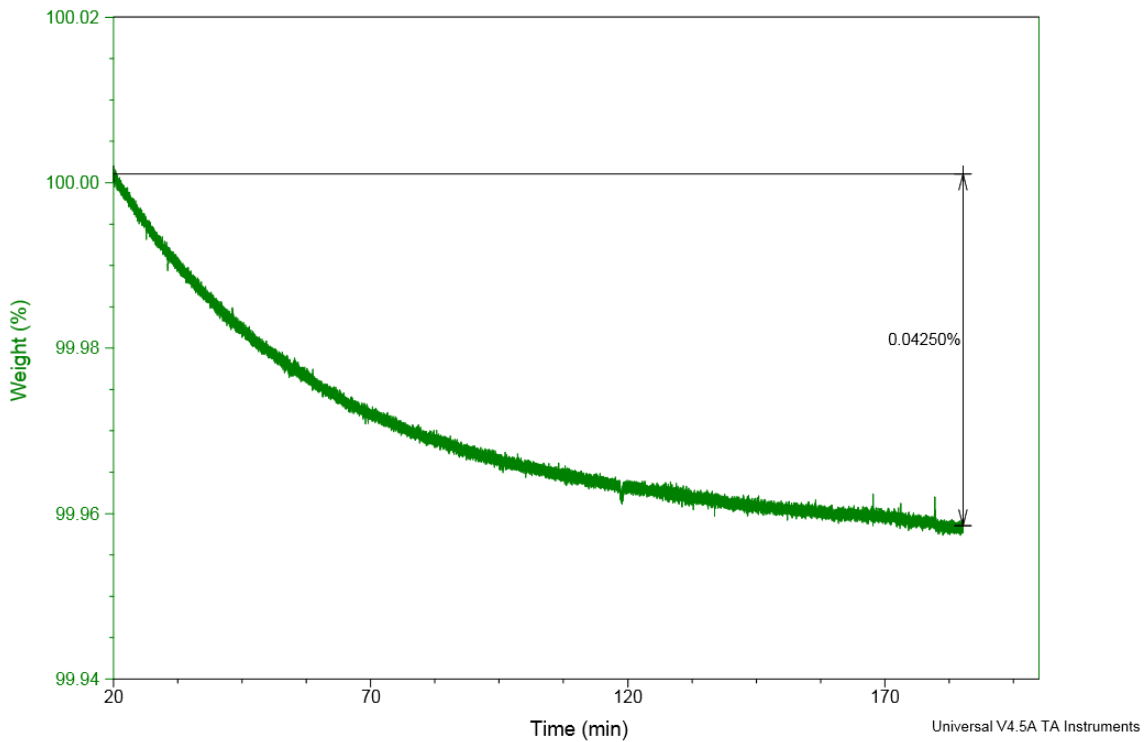
GEL 75 experienced a total mass loss of 0.042 % after a 3-hour dwell at 125°C.

Figure 4: Thermogravimetric Analysis of GEL 75 at 125°C for 3 hours

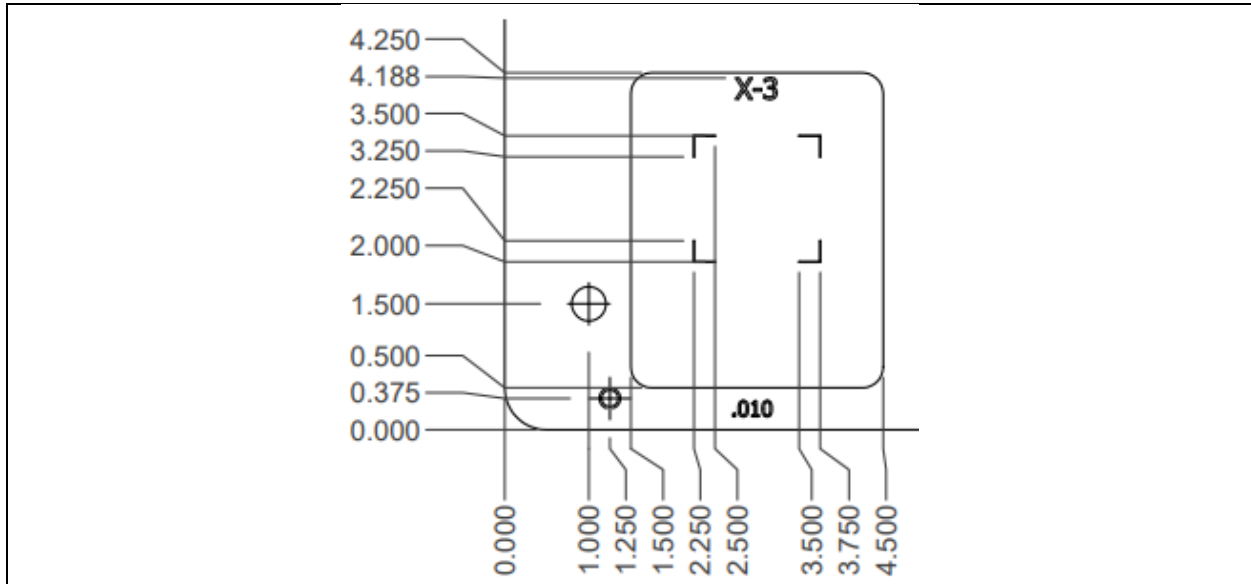
**Figure 5**– Cavity design for one of three 0.010” cavities per test plate.

GEL is dispensed in the center of the engraved 1.5” x 1.5” square of the cavity.

Additional spaces of 0.75” and 1.25” in the x and y direction, respectively, within the cavity, were designed to allow the GEL to move during stress.

Cavity surface finish: N5-N6

Mating top plate surface finish: N8

The cavity is a milled aluminum with an approximate surface finish of 16-32 Ra  $\mu$ m (N5-N6 finish). The top plate mating surface, designed to maintain the gap thicknesses within each cavity, is a sand blasted aluminum with an approximate surface finish of 125 Ra  $\mu$ m (N8 finish). After dispensing and compressing material into each cavity, x-rays were taken to visualize original position of each compressed gel dollop. After x-rays, the test fixture was subjected to the conditions detailed in Figure 2 & Figure 3 for vibration and thermal cycling, respectively. Post-stress, x-rays were taken again to visualize displacement of gel within each cavity.

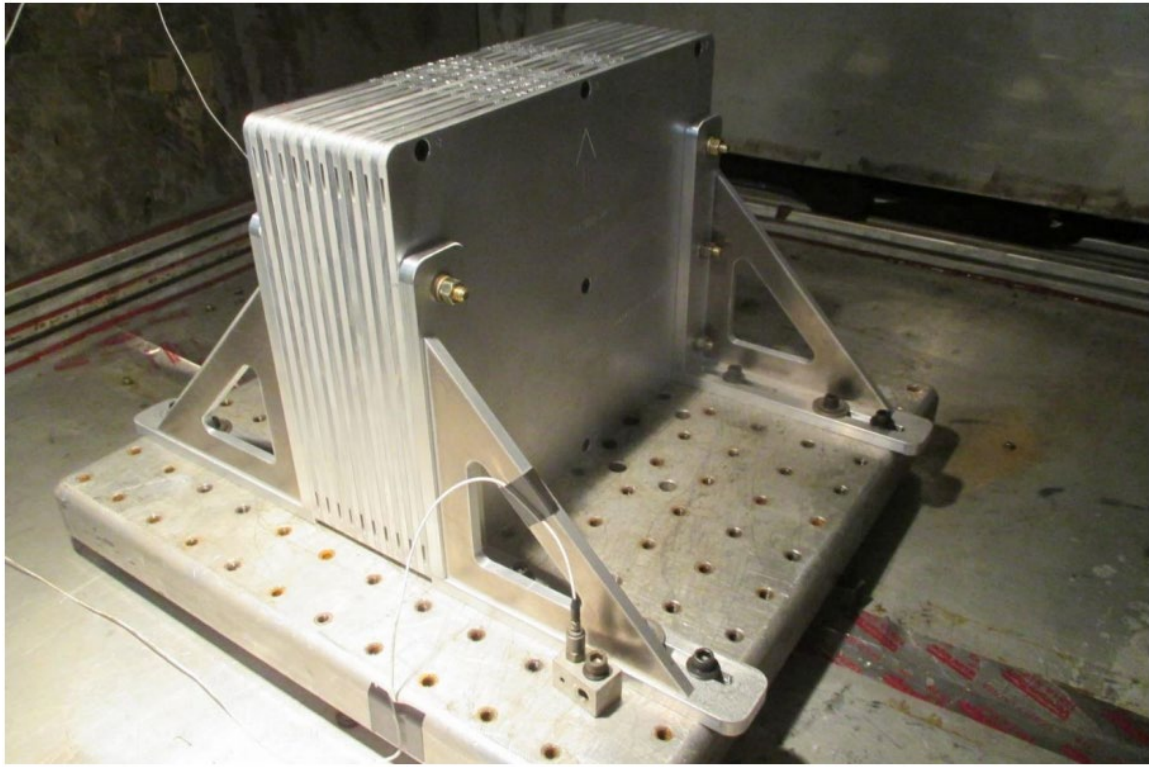
**Figure 9 – Vibration with Thermal Cycling, Vertical Axis**

The samples were subjected to this vibration for 81 hours in each of three (3) mutually perpendicular axes for a total accumulated vibration time of 243 hours.

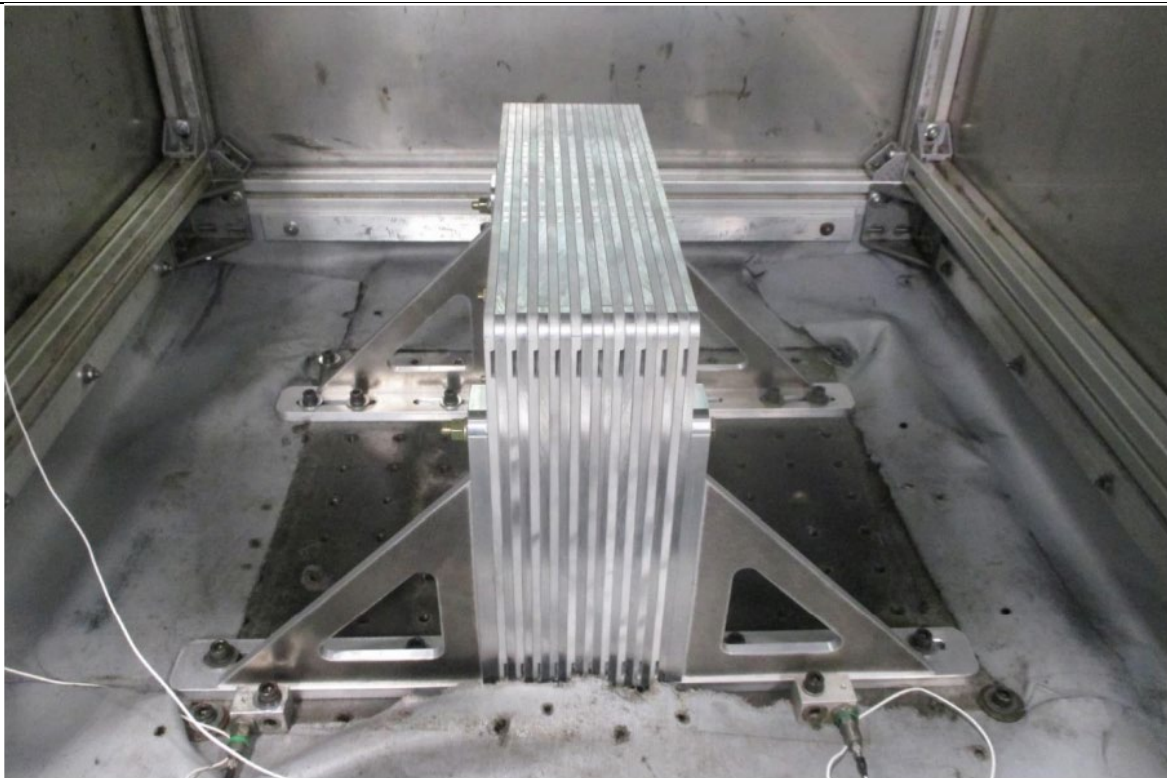
**Figure 10 – Vibration with Thermal Cycling, First Horizontal Axis**

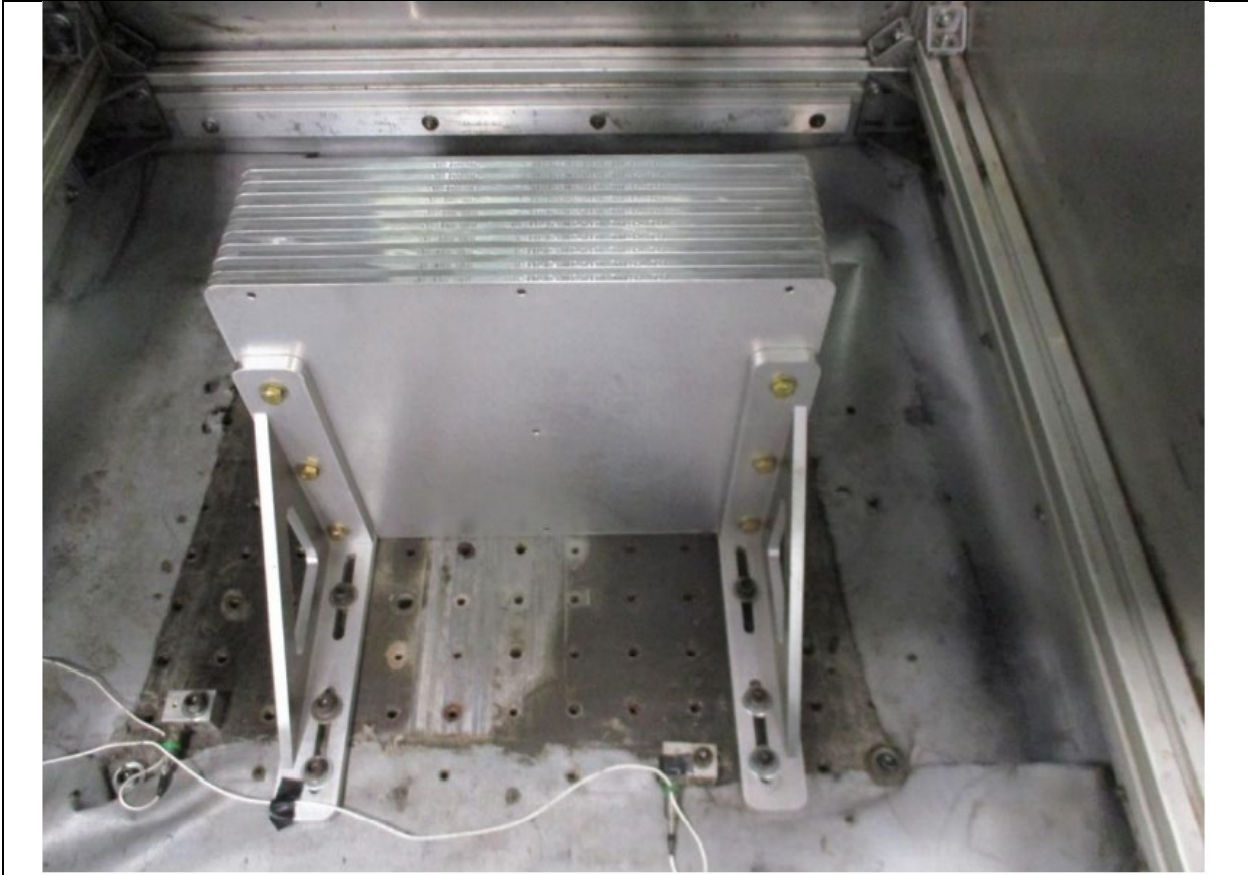
**Figure 11 – Vibration with Thermal Cycling, Second Horizontal Axis**

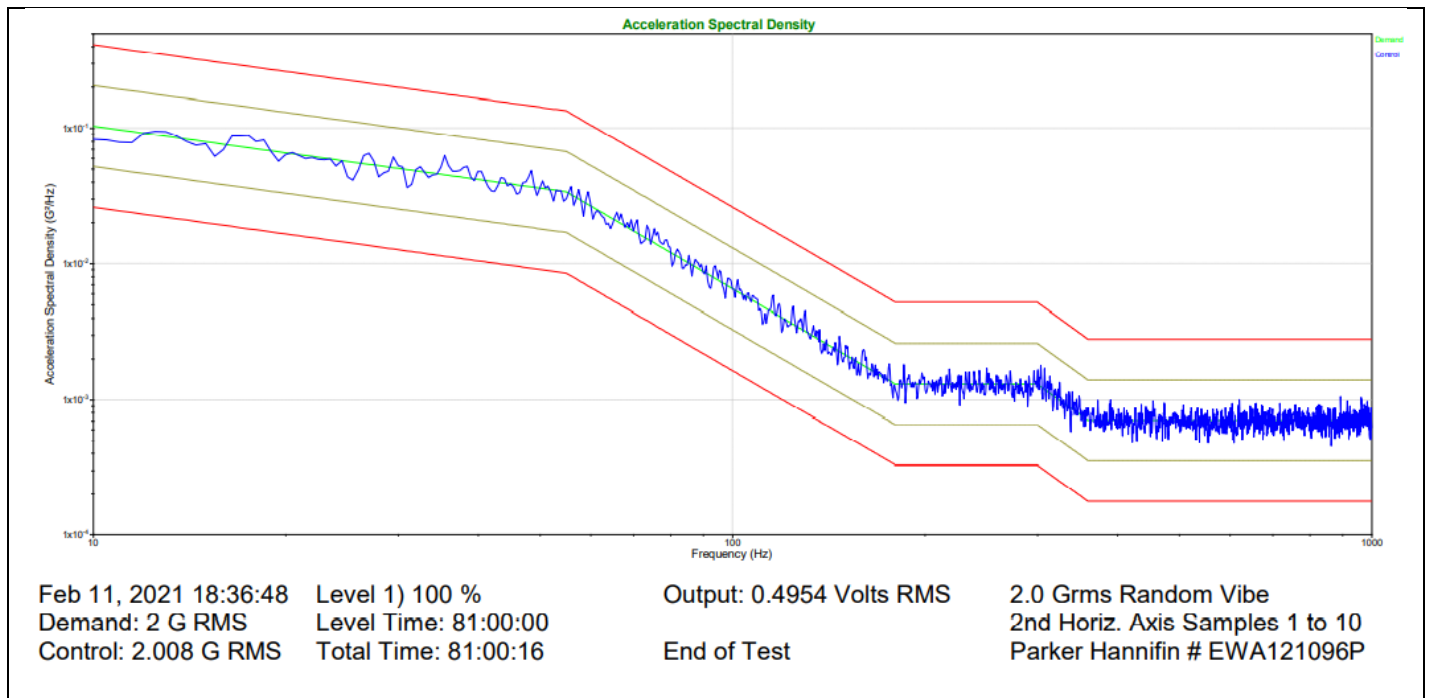
**Figure 12 – Acceleration Spectral Density**

The samples were subjected to a random vibration at all frequencies from 10 Hz to 1000 Hz per the break point table above.

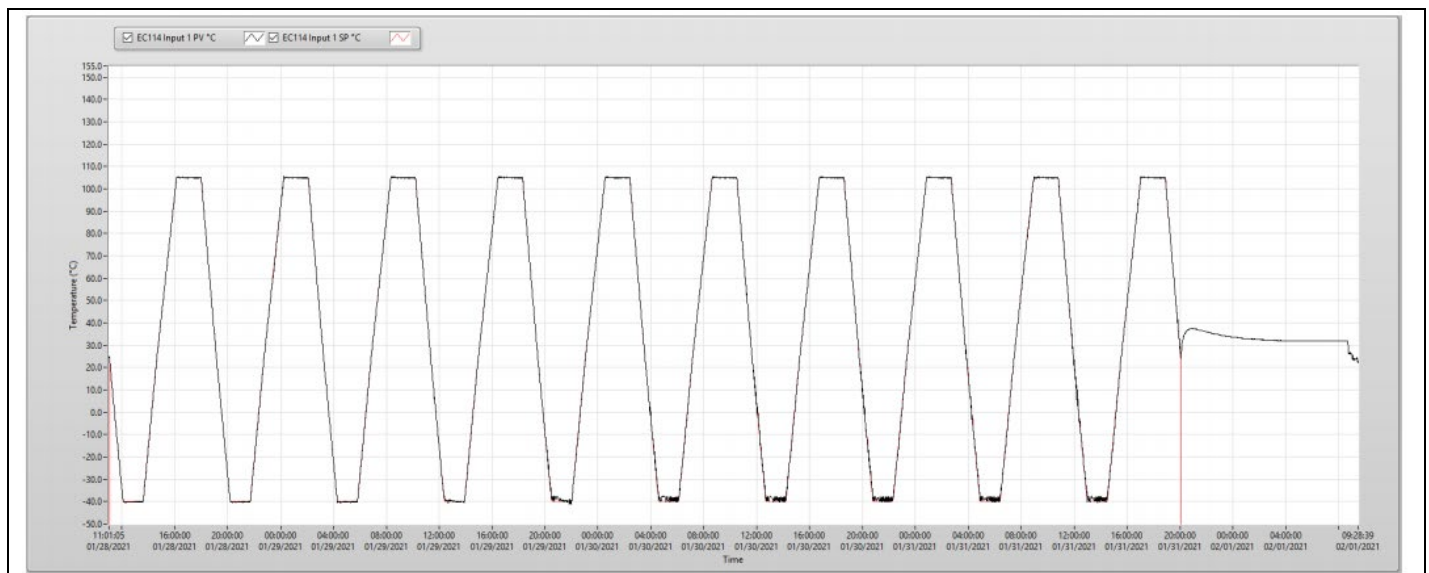
**Figure 13 – Thermal Cycling Profile**

The samples were exposed to the above temperature profile during vibration testing

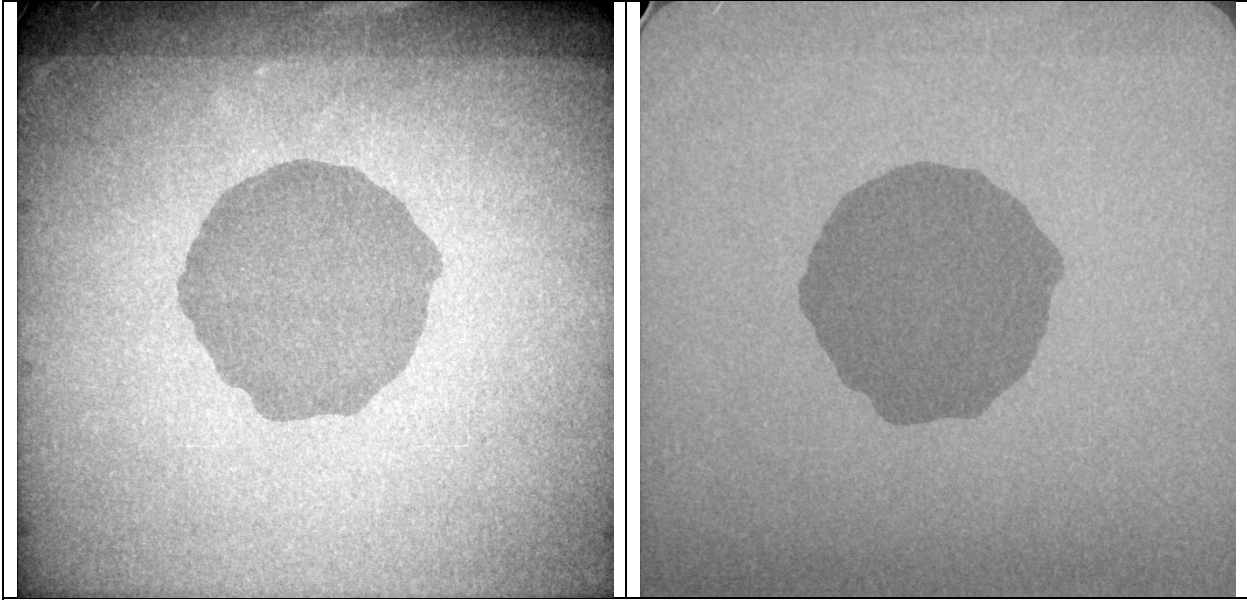
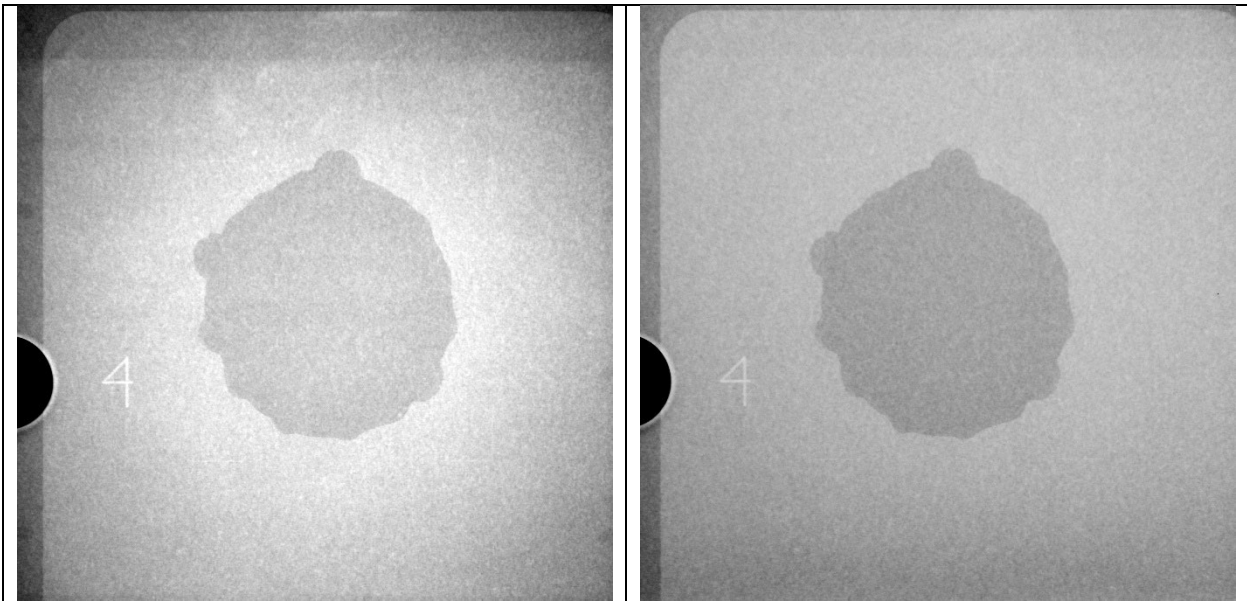
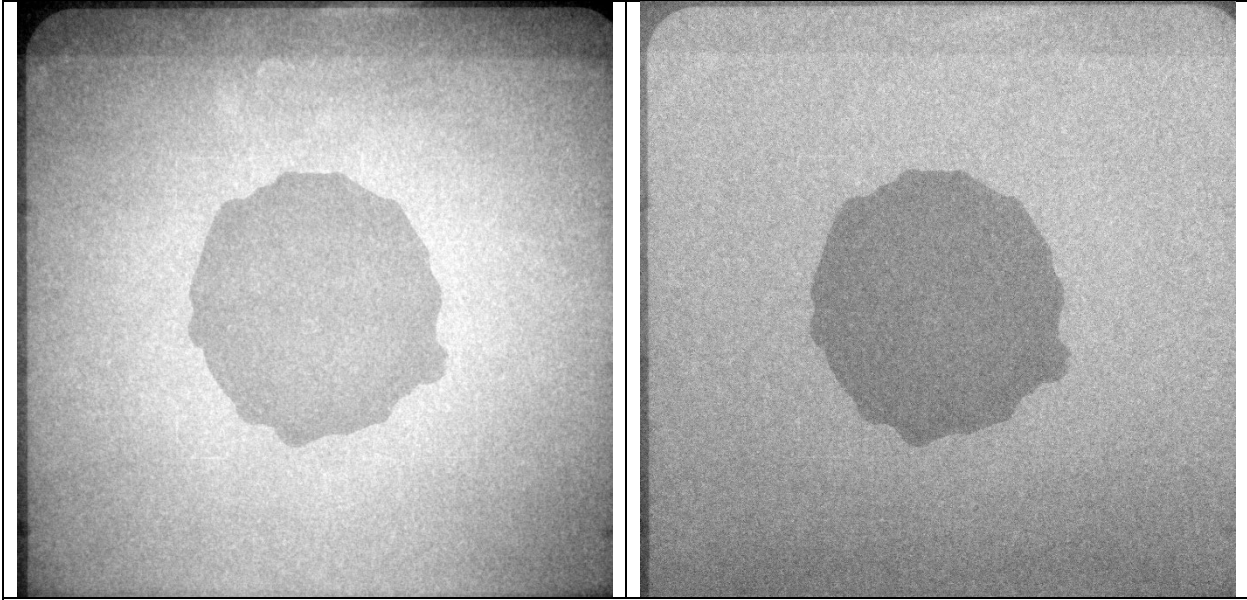
Figure 14– 0.010", cavity 1, pre-stress (left) and post-stress (right) x-rays

Figure 15 – 0.010", cavity 2, pre-stress (left) and post-stress (right) x-rays

**Figure 16** – 0.010", cavity 3, pre-stress (left) and post-stress (right) x-rays

The results show minimal displacement / cracking of the gel samples from their original compressed location within the test fixture.

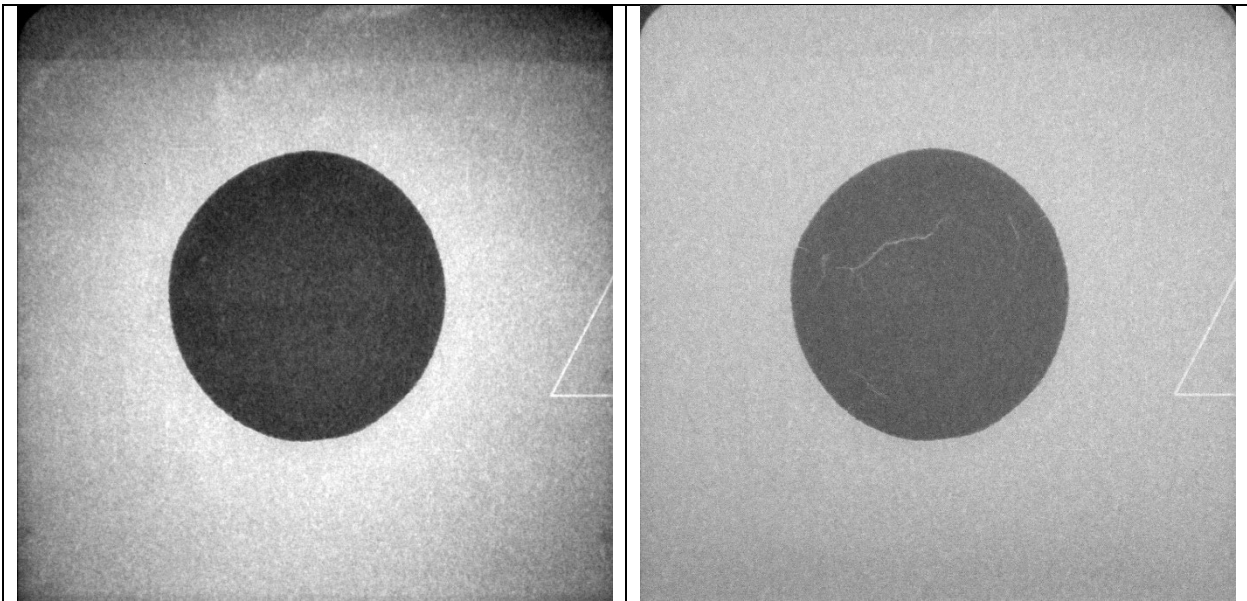
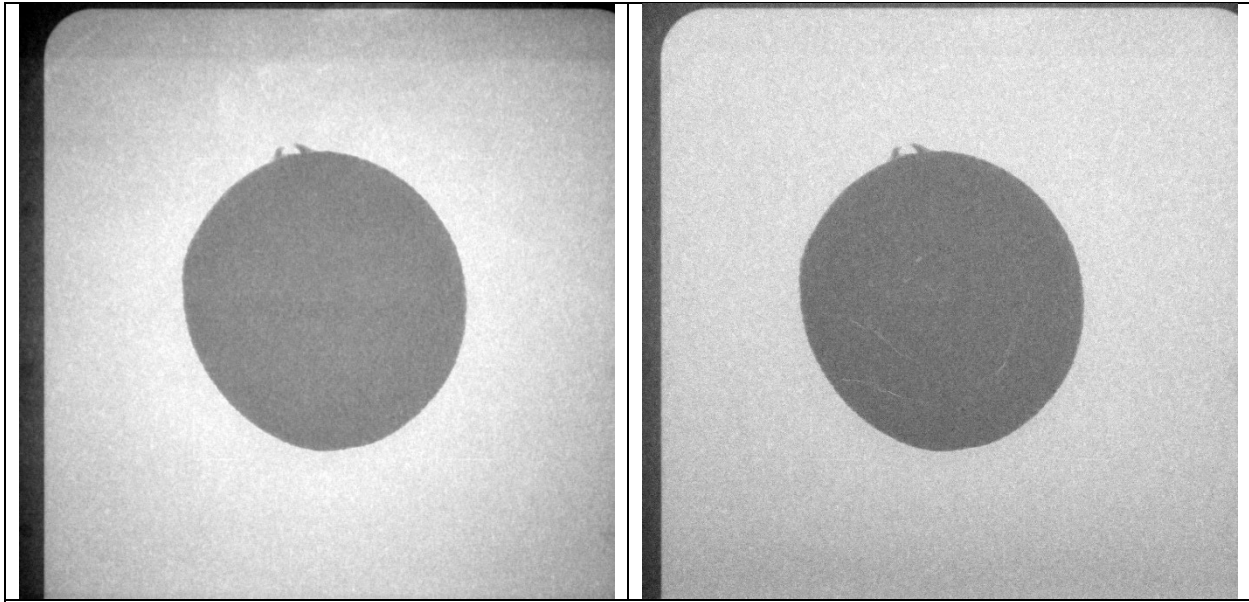
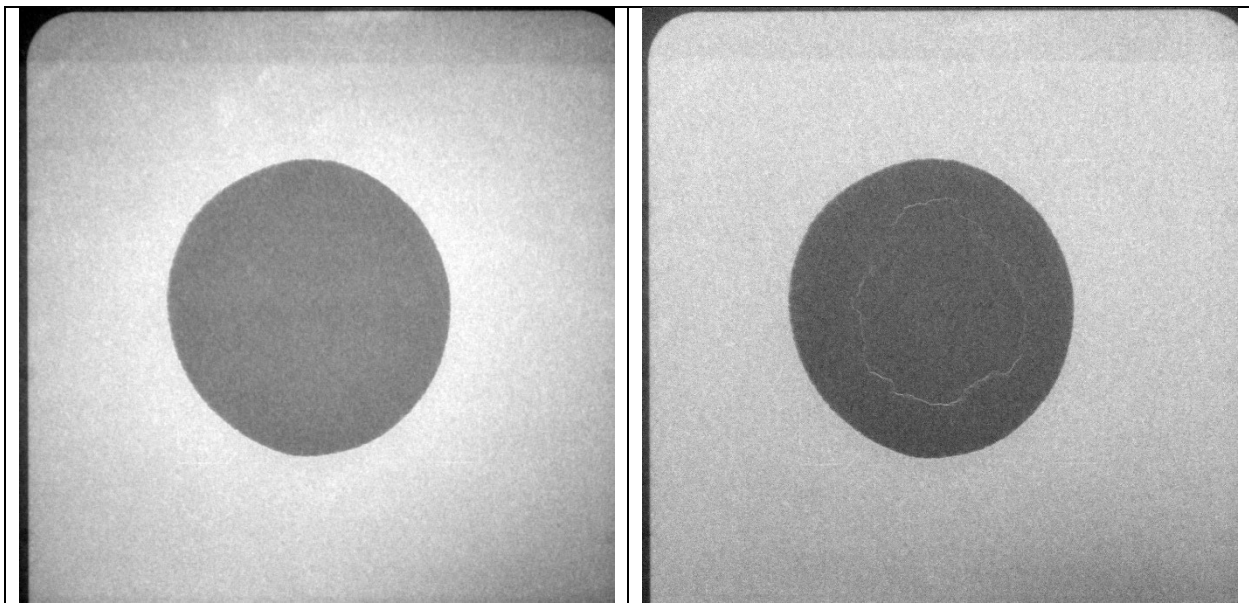
**Figure 17** – 0.040", cavity 1, pre-stress (left) and post-stress (right) x-rays

**Figure 18** – 0.040", cavity 2, pre-stress (left) and post-stress (right) x-rays

**Figure 19** – 0.040", cavity 3, pre-stress (left) and post-stress (right) x-rays
