# CASE STUDY

No: 11  
Date: April 2008

## Avoiding Welding on a production platform

**Market:** Offshore Oil & Gas  
**Product:** Phastite

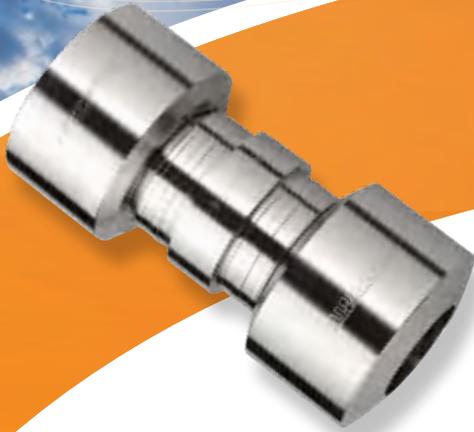
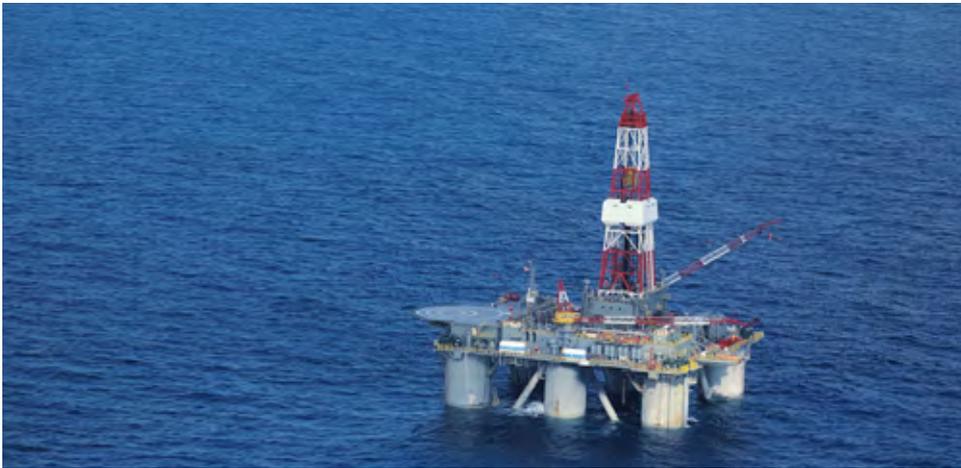
Important hydraulic services in the vicinity of the platform's drilling area were damaged. Some of the damaged lines were fabricated from heavy-wall 1-inch tubing, and it was impossible to repair using traditional twin-ferrule compression tube fittings. Welding in new sections was highly undesirable, due to the location, and the costly downtime that would be necessary. A repair by means of special flanges was feasible, but these products had

Phastite fittings offered a high-pressure connection system that slid over the tubing, and is capable of being compressed onto thick wall (or thin wall) tubing using a portable hydraulic tool.

Once approval to proceed was received, AFST arranged a short Phastite training course for the contractor's project personnel, and provided the Phastite fittings required and the loan of the assembly tool. The contractor completed the repairs speedily and without disrupting production, despite some severe accessibility problems in the crowded hydraulic services area. The tool's compact jaws allowed the tubing repairs to be made in situ, despite the proximity to many other tubing runs and connections (see photos overleaf).

Phastite avoided welding and any need for 'hot work permits' (which were virtually impossible to obtain in this particular case) — providing a fast repair.

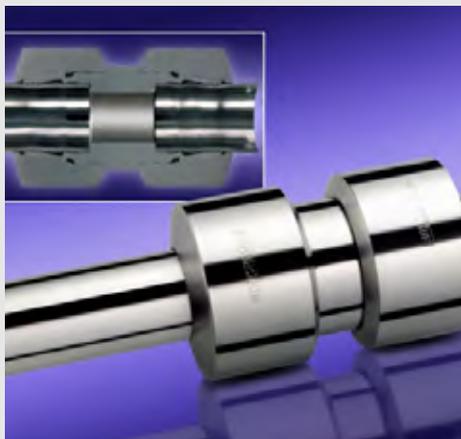
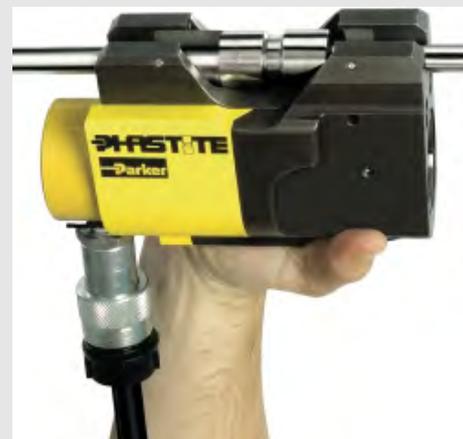
Phastite is a new type of fluid connection providing permanent connections for fluid systems operating at up to 20,000 PSI / 1,379 bar. For permanent connections, and these elevated pressures, system builders would typically use either welded or 'cone and thread' style fittings, which are time consuming and expensive to install. Compared with these products, Phastite connectors can reduce installation costs by a factor of 90% or more. Phastite employs a compression assembly principle using a novel form of toothed profile, which makes the seal. The connectors are supplied as one-piece components. To make a joint, all that's required is to insert the tube, and then push the collar along the connector body until it reaches a dead stop. This

operation is performed by a simple hydraulic tool (the tool is handheld for smaller joints - up to 1/2 inch / 12 mm), and takes a few seconds. The tool requires no skill to use, and assures users of right-first-time connections. This assembly approach contrasts with the requirement to perform a 360-degree weld around the circumference of a tube, an operation requiring skill, consumables, expensive equipment, and up to 10 minutes of time. Or, the coning and threading of a tube end to prepare it for use in a special screw-together fitting, operations that again require skill, and time - in this case up to 30 minutes or more. For many applications, the quality of the weld is also tested by means of dye penetration, or x-ray inspection, adding further substantial costs.

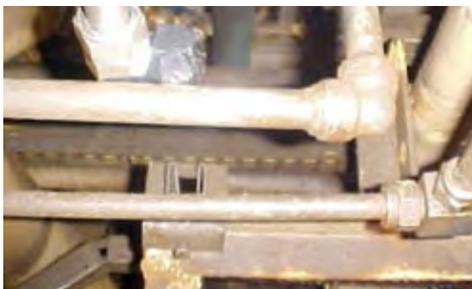
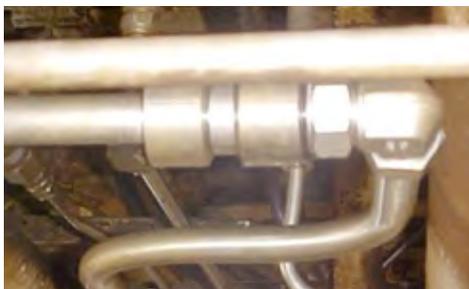
## Some views of Phastite repairs on the platform.

Before (left), and after shown right:
