# THERM-A-GAP™ GEL 37 Reliability Report

## TR1103 February 2020 Rev. A

Chomerics Division of Parker Hannifin  
77 Dragon Court, Woburn, MA 01888  
(781) 939-4623

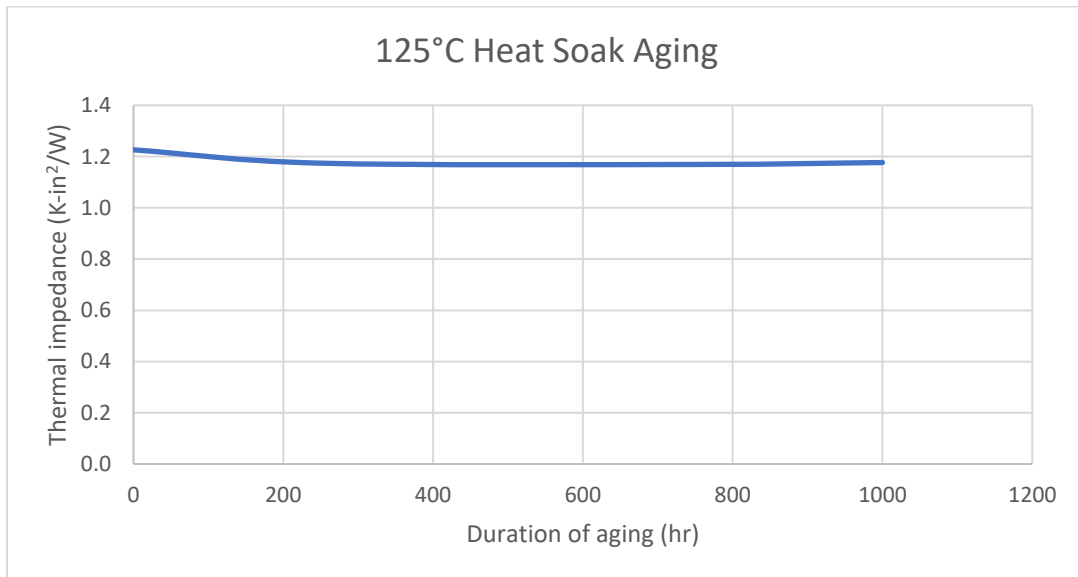
Figure 1: Dry heat aged thermal impedance versus time

The mean impedance values after dry heat aging, heat and humidity aging, and temperature cycling decreased by 4.0%, 2.6%, and 0.1% respectively. A substantial decrease in impedance represents improved thermal performance, and this phenomenon may be attributed to enhanced wetting at the interface between the thermal compound and the substrate.

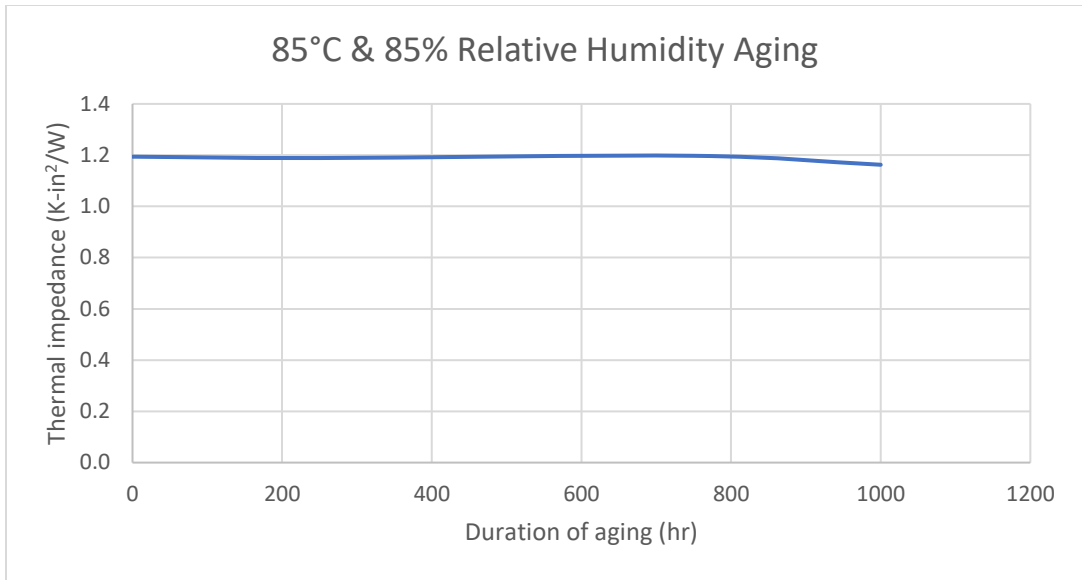
Figure 2: Heat & humidity aged thermal impedance versus time

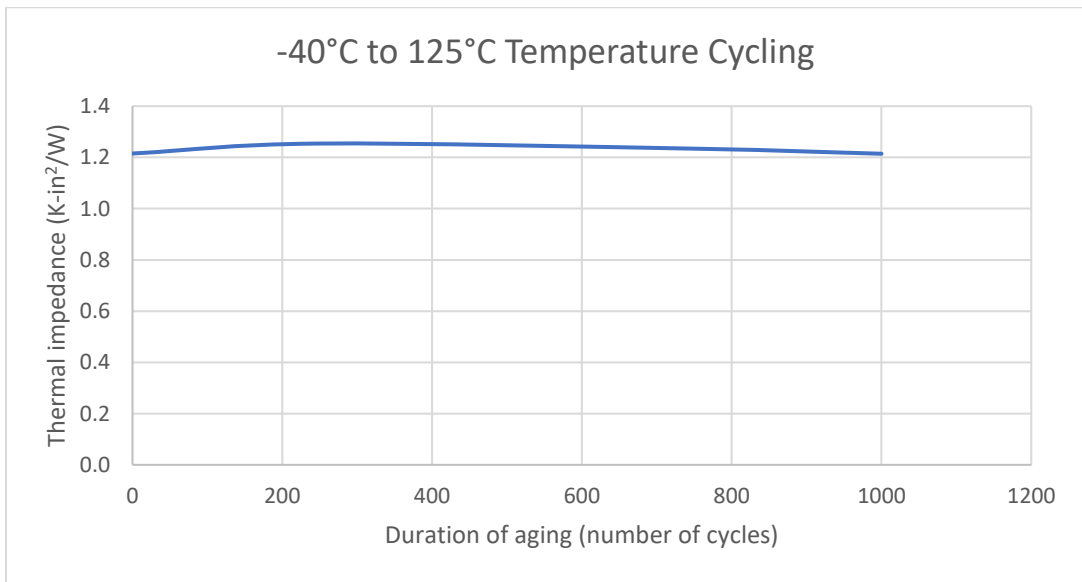
Figure 3: Temperature cycling thermal impedance versus elapsed cycles

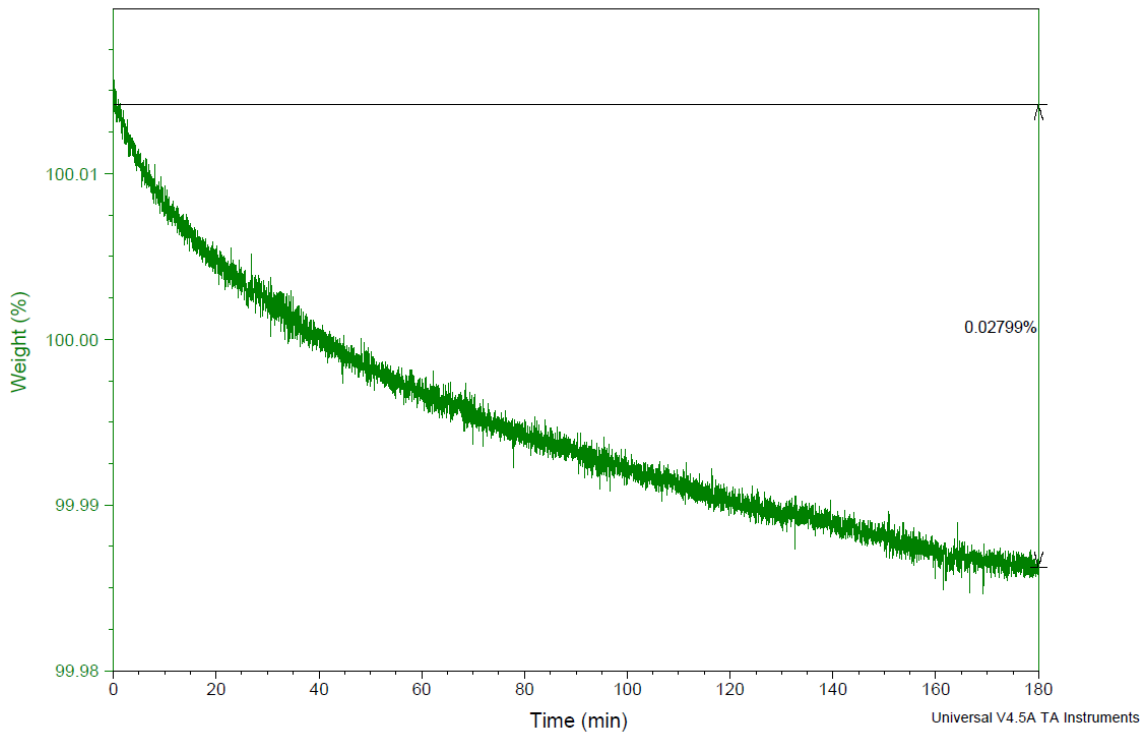
GEL 37 experienced a total mass loss of 0.028% after a 3-hour dwell at 125°C.

Figure 4: Thermogravimetric Analysis of GEL 37 at 125°C for 3 hours
